D
State of California	R
California Regional Water Quality Control Board, Los Angeles Region	\mathbf{A}
	\mathbf{F}
	_
Draft Technical Staff Report	T
Evidence in support of an	
Amendment to the	\mathbf{J}
Water Quality Control Plan for the Coastal Watersheds	U
of Los Angeles and Ventura Counties	Ł
to Prohibit On-site Wastewater Disposal System	¥
in the Malibu Civic Center Area	
	3
	1
	*
Technical Memorandum #5:	0
Dischargers with Unsuitable Hydrogeologic Conditions for High Flows of	<u>O</u> <u>C</u>
Wastewaters Resort to Hauling Liquid Sewage and Sludge to Communities that	<u>C</u>
have Sewer and Wastewater Treatment Facilities	$\mathbf{\underline{T}}$
	2
	1
	<u></u>
	2
	_
by	0
Dionisia Rodriguez, Environmental Scientist Ryan Thacher, Student Intern	0
Groundwater Permitting Unit	9
-

Technical Memorandum 5: Dischargers with Unsuitable Hydrogeologic Conditions for High Flows of Wastewaters Resort to Hauling Liquid Sewage and Sludge to Communities that have Sewer and Wastewater Treatment Facilities D

by Dionisia Rodriguez, Environmental Scientist Ryan Thacher, Student Intern Groundwater Permitting Unit

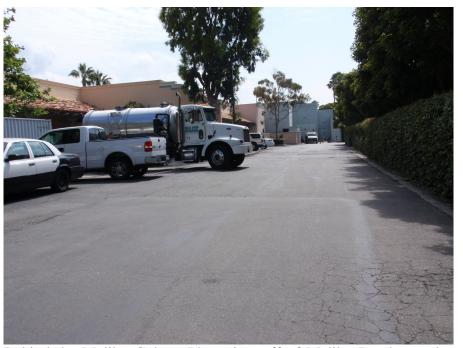
Behind the Malibu Colony Plaza, just off of Malibu Road, we observed an Ely Jr's Pumping truck.

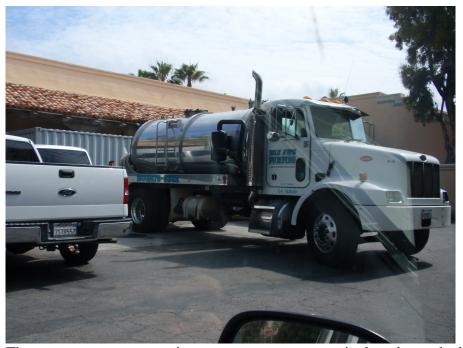
The operator was preparing to pump, so we waited and watched to observe any notable information about this process.

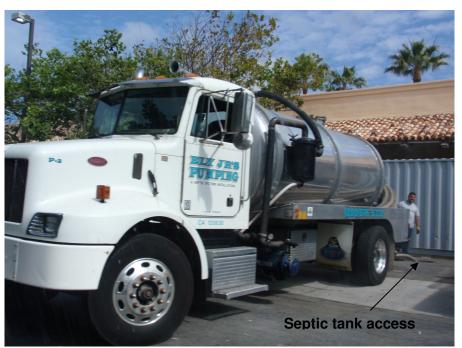
While pumping, there was a very strong stench of raw sewage, and noise levels required raising your voice significantly for conversation. No spills or leaks were observed during the pumping process.

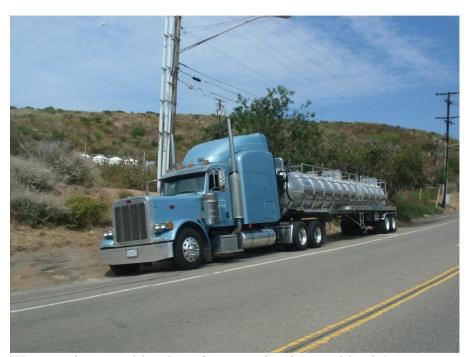
We were interested in observing pumping in a residential area, so we arbitrarily chose to drive north on Winter Canyon Road. At this location at 11:00 a.m. we encountered a large, unmanned sewage hauling truck belonging to Ely Jr's Pumping. We believe it was parked next to the leach field at Winter Canyon Road.

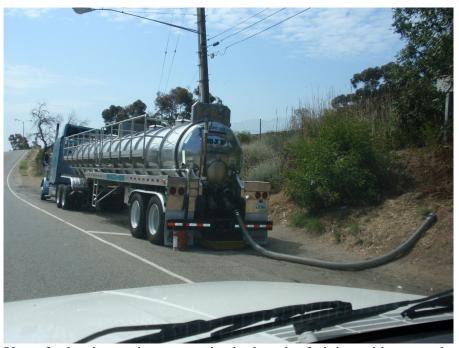
Upon further inspection, we noticed a length of piping with one end attached to the truck's tank, and the other laying freely on the side of the road.
